5.0 INSPECTION OF EMBANKMENT DAMS

5.1 INTRODUCTION

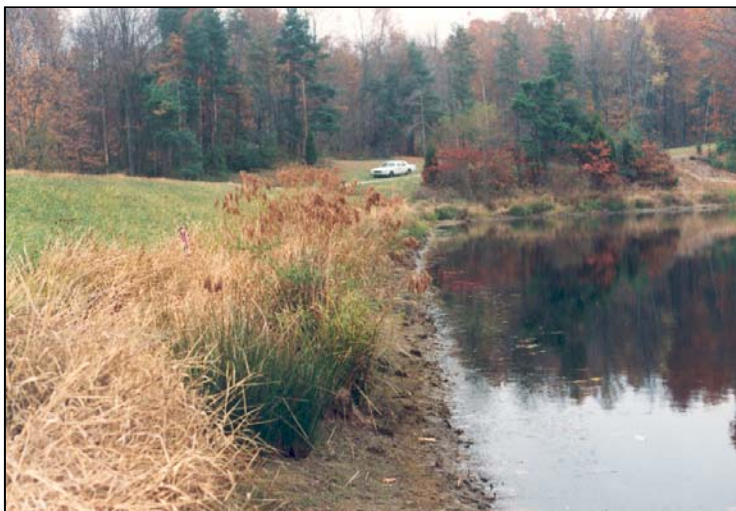
Figure 5-2 Embankment slope inspection can be hindered with excessive vegetation.

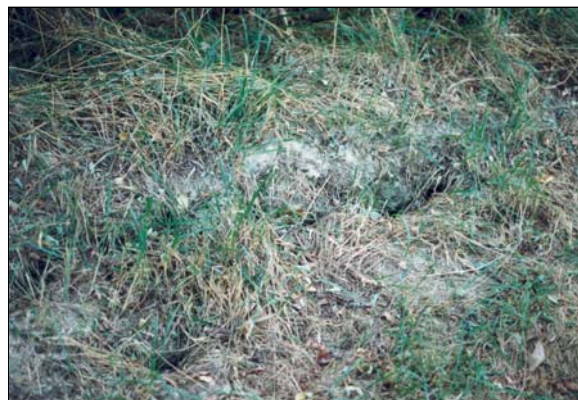
Figure 5-3 Longitudinal cracks on embankment slope.

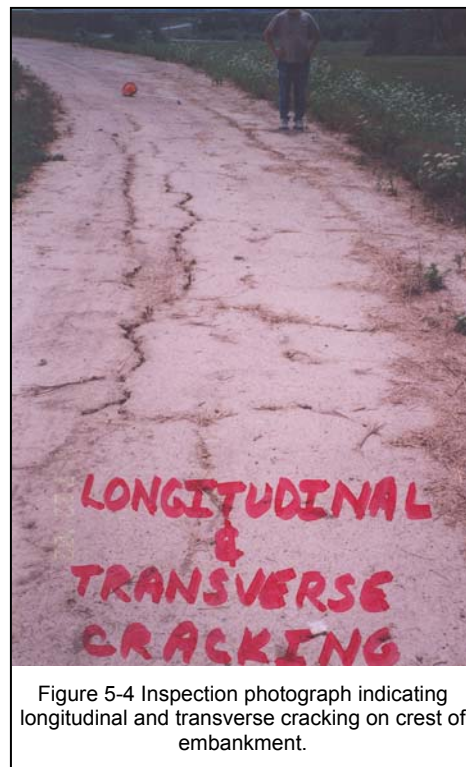
Figure 5-4 Inspection photograph indicating longitudinal and transverse cracking on crest of embankment.

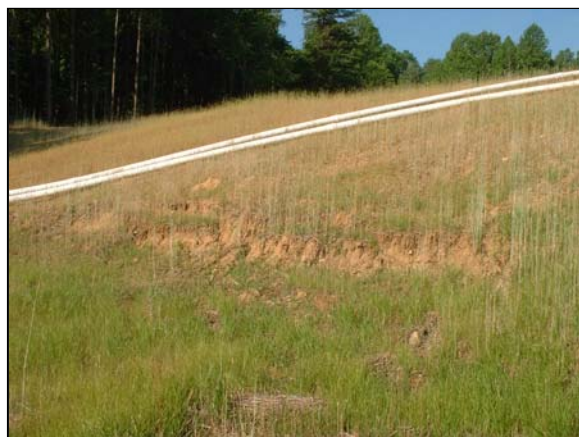
Figure 5-11 Shallow slide at toe of embankment resulting from excessive seepage and poor compaction.

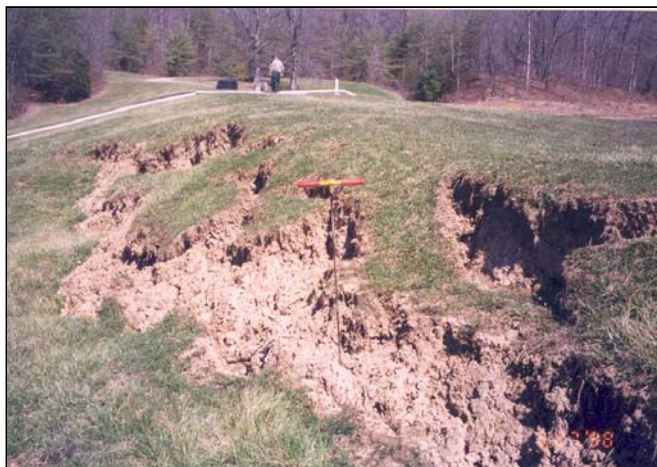
Figure 5-14 Large slide on embankment with prominent scarp.

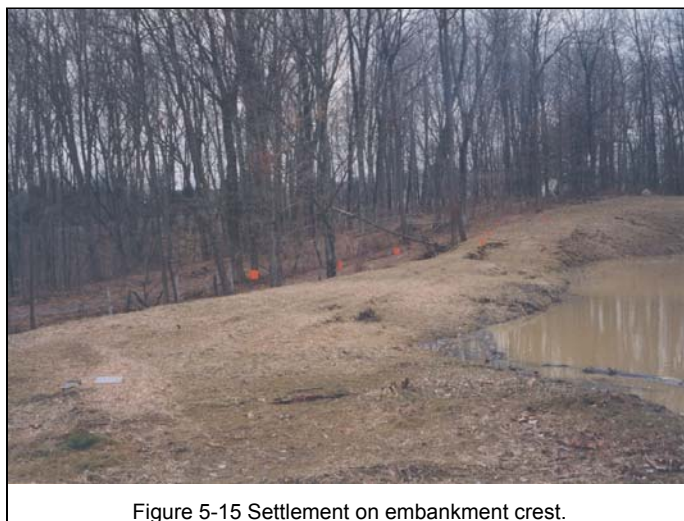
Figure 5-15 Settlement on embankment crest.

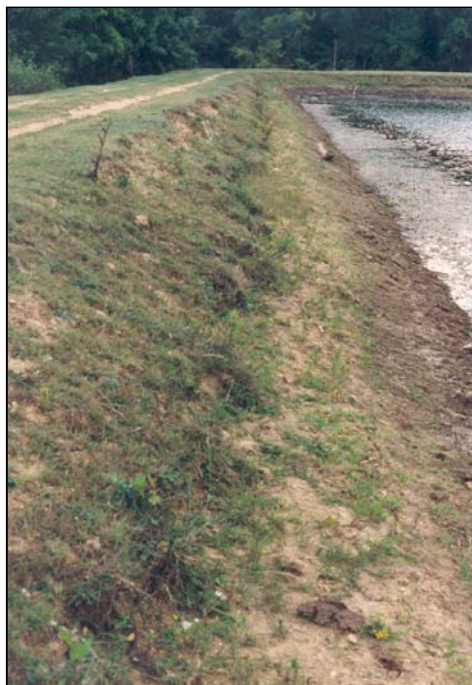
Figure 5-19 Inadequate slope protection resulting in shoreline erosion.

provides excellent protection against erosion caused by rainfall and runoff. Deep-rooted grass that can tolerate repeated wetting and drying cycles should be used on embankments. Figure 5-19 shows an embankment experiencing shoreline erosion as a result of inadequate slope protection. The shoreline has no riprap and insufficient vegetative cover.

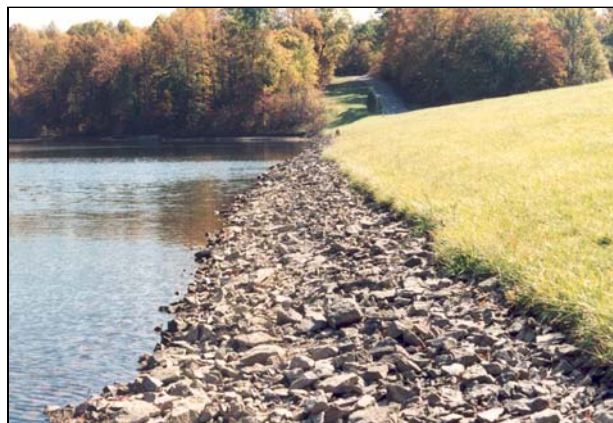
Figure 5-18 Riprap protection on the embankment slope at the shoreline, with grass on the rest of the slope.

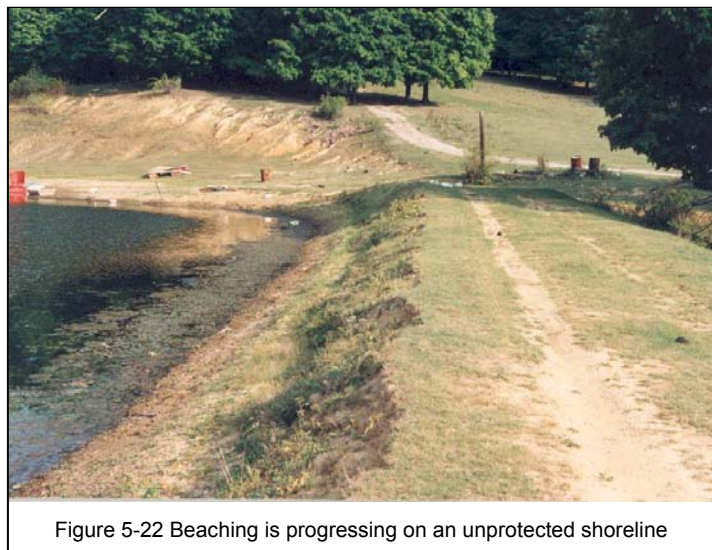
Figure 5-22 Beaching is progressing on an unprotected shoreline

Figures 5-21 and 5-22 show the effects of erosion and beaching on the upstream slope of a dam. When beaching occurs, embankment material is deposited farther down the slope. In this extreme form of erosion, the slope protection (i.e., riprap or vegetative cover) and underlying material are removed. A relatively flat beach area with a steep back slope, or scarp, is formed. Scarps should be monitored regularly for additional deterioration and repaired if conditions get worse.

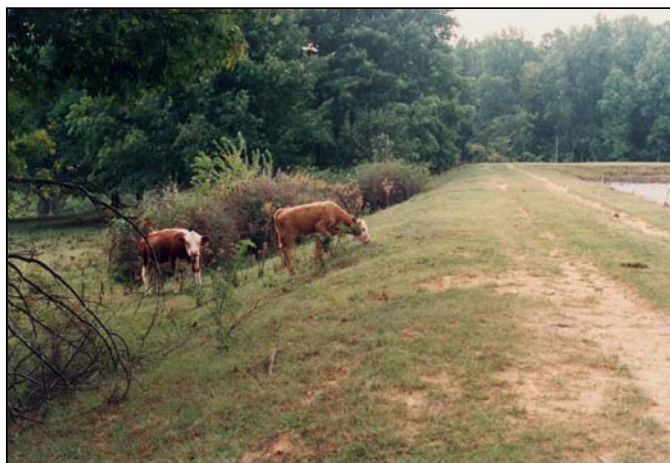
Figure 5-23 Cattle grazing on a dam embankment can lead to erosion problems.

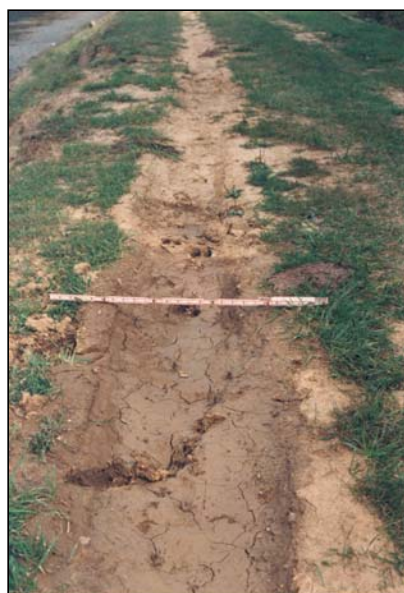
Figure 5-24 Vehicle traffic can kill vegetation and result in erosion.

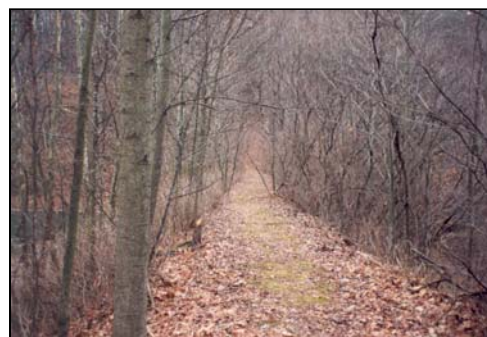
Figure 5-25 Trees and brush on an embankment pose a stability risk and can impede visual inspection.

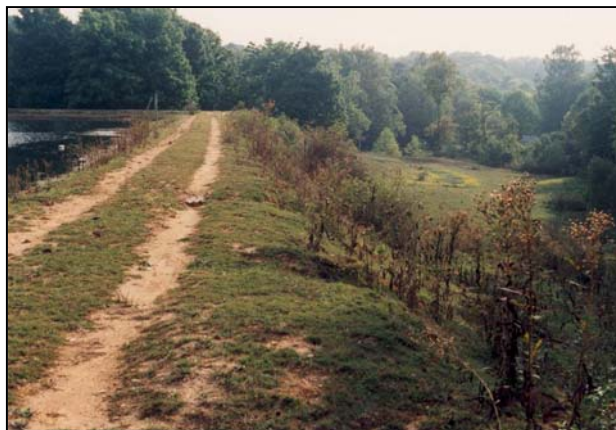
Figure 5-26 Insufficient vegetation on embankment crest and slopes will result in accelerated erosion.

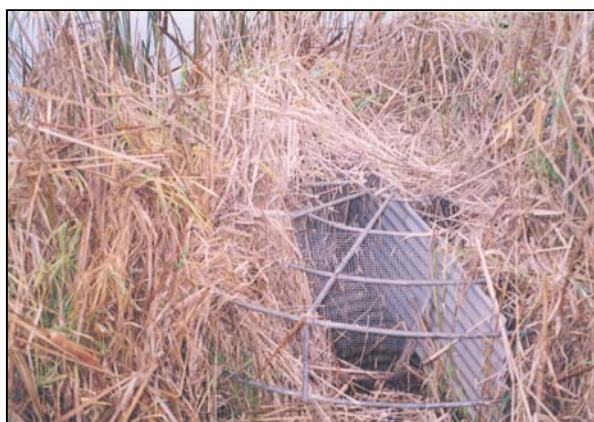
Figure 5-27 Excessive vegetation around this riser and trash rack makes visual inspection almost impossible.

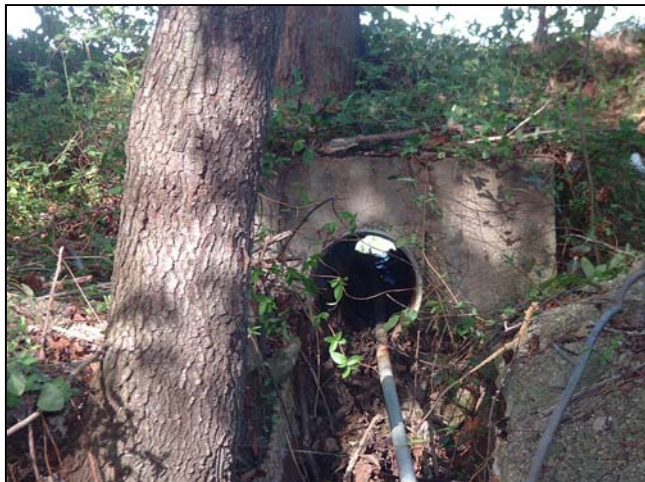
Figure 5-28 A tree is growing over the top of this spillway conduit.

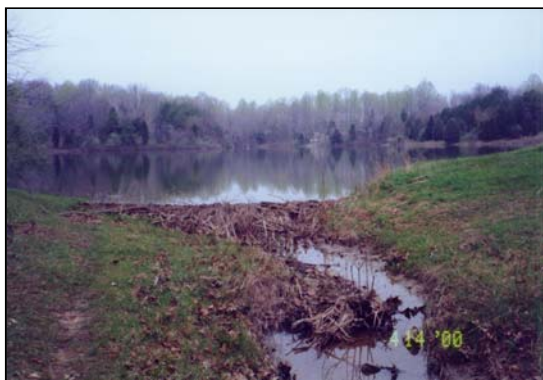
Figure 5-30 A beaver has blocked the spillway on this dam.

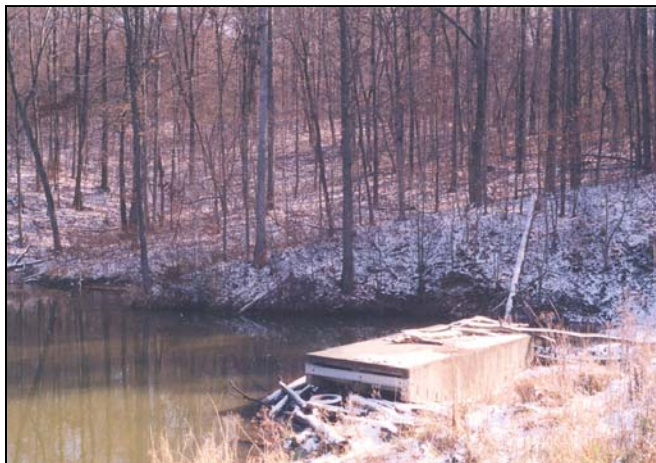
Figure 5-29 Excessive debris around the riser trash rack can reduce discharge capacity and increase water levels.

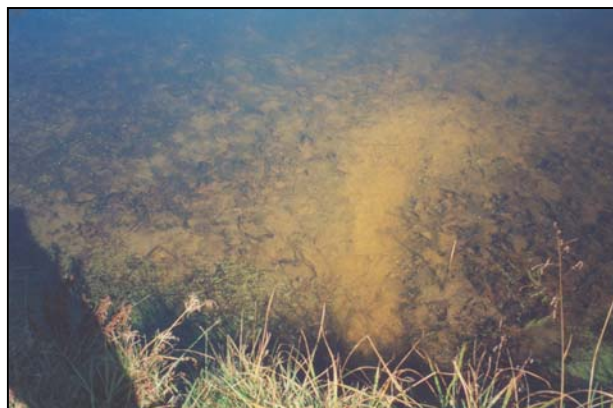
Figure 5-31 Telltale signs of a muskrat burrow.

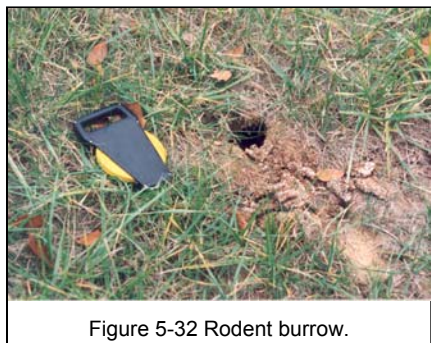
Figure 5-32 Rodent burrow.

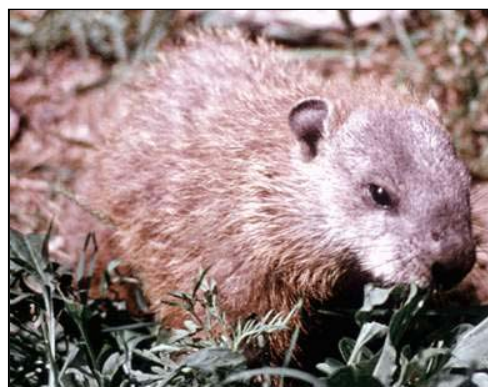
Figure 5-33 Groundhogs can make extensive burrows in an embankment.

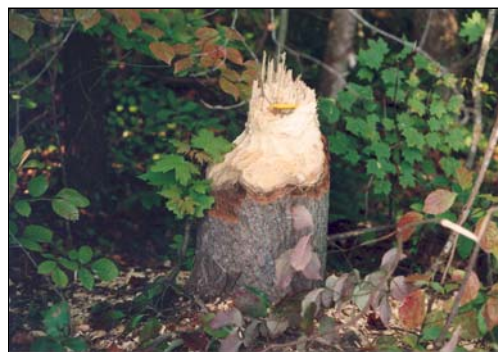
Figure 5-34 Telltale signs of a beaver.

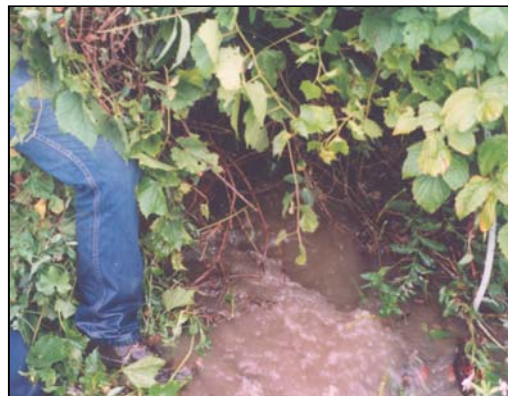
Figure 5-37 Piping through the foundation; notice the turbid discharge.

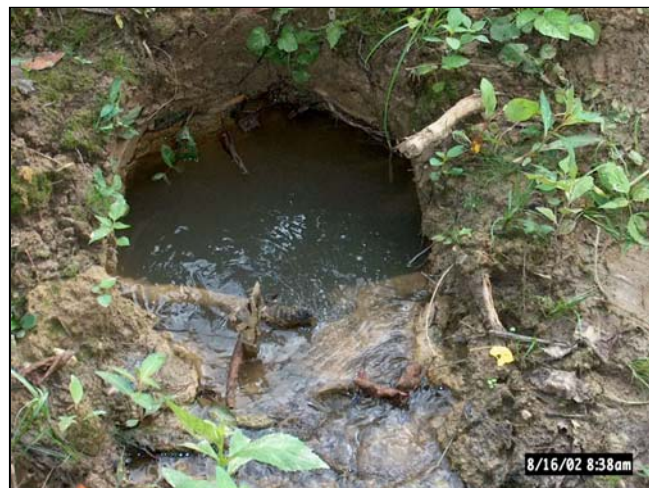
It can be difficult to determine the source of seepage, since the exit may be the only visible condition observed. The seepage pipe shown in Figure 5-40 was observed a few feet below the toe of an earth embankment, and it was not clear whether the water was flowing through the embankment or under it.

Figure 5-40 Piping with clear discharge may indicate that no additional soil is being removed from the foundation.

No sand or other soil was being carried by the seeping water, and the reservoir level was slowly getting lower, so the pipe was probably already formed. Seepage may originate in the bottom of the reservoir, upstream of the embankment, and travel through porous soil strata in the foundation of the dam.

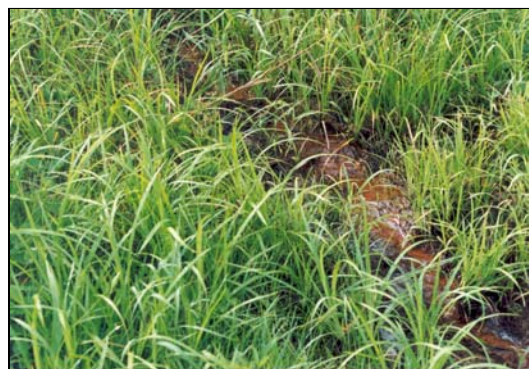
Figure 5-41 This seepage has produced iron oxide stains.

compaction is difficult along the embankment and abutment interface. Also, improperly sealed porous abutment rock can introduce abutment seepage into and along the embankment. Seepage in the groins may be groundwater from the abutments or valley walls, and not seepage from the reservoir. Seepage which exhibits an orange color or oily surface sheen typically indicates the presence of dissolved iron in the water. This is a common condition of groundwater that has been in contact with iron-bearing soils. The orange coloration is from iron oxide which develops after the groundwater is exposed to the air, causing the dissolved iron to oxidize (rust) and settle out of the water. The orange coloration is from deposits of iron oxide on the ground, and is not orange water.

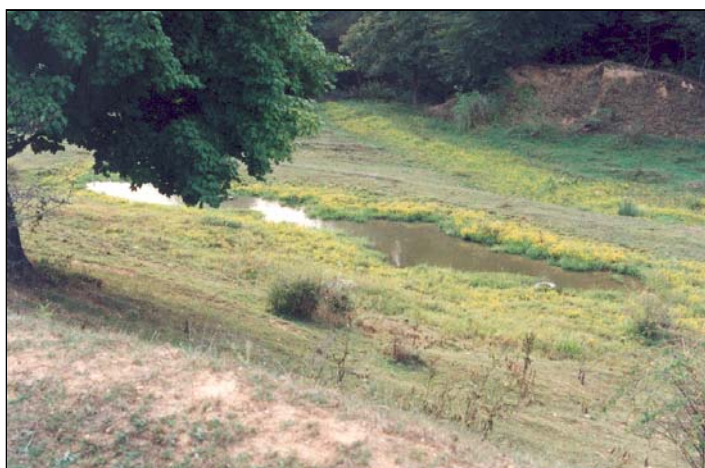
Figure 5-42 Excessive seepage near embankment toe.

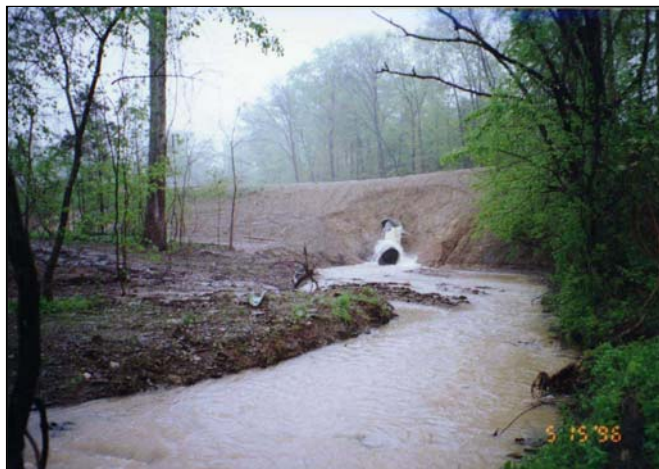
Figure 5-43 Seepage along the spillway in this dam has resulted in piping and a serious leak.

Rapid erosion and an eventual breaching of the dam can result from seepage around conduits. Figure 5-43 shows serious piping along a spillway conduit. This type of seepage is excessive and will continue to erode the soils around the conduit.

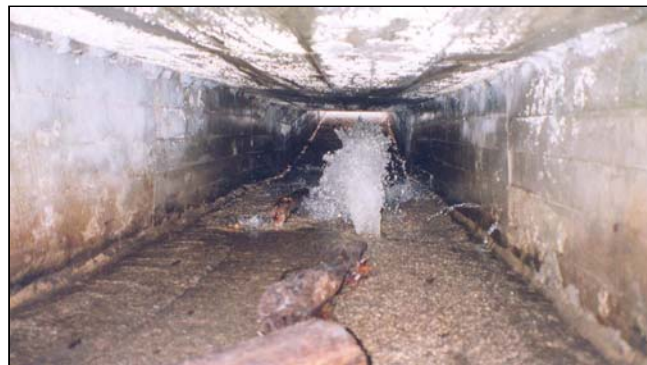
Figure 5-44 Seepage under this spillway conduit has caused piping, allowing a significant leak through conduit deficiencies.

Seepage along and under spillway conduits can find its way into the conduits, eventually eroding and deteriorating the conduit itself, as well as removing soil and bedding material from under the conduit. The conduit may settle or collapse if sufficient soil is piped out from under the structure. This type of seepage can be best observed when reservoir levels are below the spillway crest. In this situation, water will typically be coming out of the spillway conduit but will not be entering it from the inlet of the spillway in the reservoir. Many times sediment, or deposited soils, will be visible within or at the outlet of the conduit. High reservoir water levels will aggravate this condition.

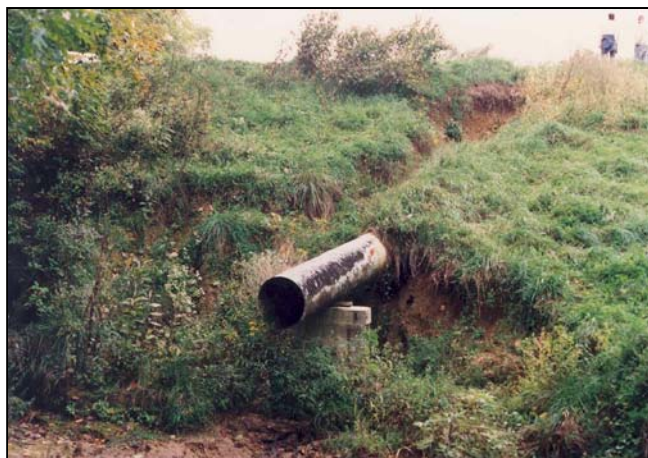
Figure 5-45 Seepage along this spillway conduit has caused piping, sinkholes, and eventual erosion of all the soil over the conduit.

Another usual symptom of seepage and piping along the conduit is settlement and depressions above the conduit, particularly within the conduit trench. Again, this is the result of the removal of soil from around the conduit, allowing it to be replaced by surface soils which fall into the voids created by the piping condition.

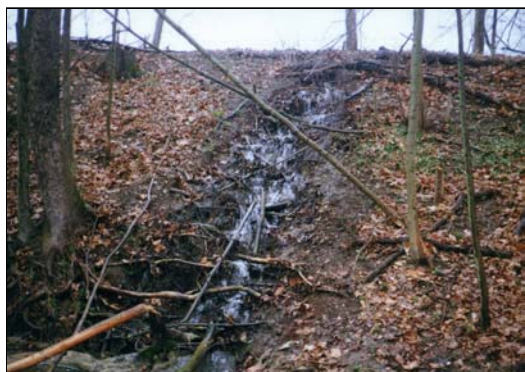
Figure 5-46 Seepage caused by tree roots through the embankment.

Seepage can be caused by deep-rooted vegetation on embankments, such as trees. Tree roots can penetrate the embankment and create passageways for water. Seepage along roots systems will usually start off at a very slow rate and get progressively greater with time. This is another example of the importance of early detection of seeps. As discussed earlier in this chapter, uprooted trees can also cause seepage problems.

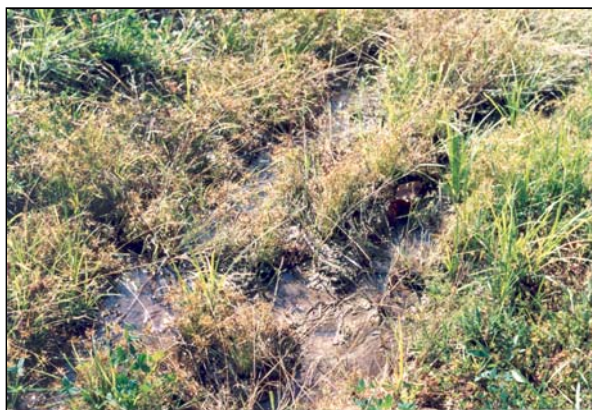
Figure 5-47 Typical photograph of seepage accumulating in low areas.

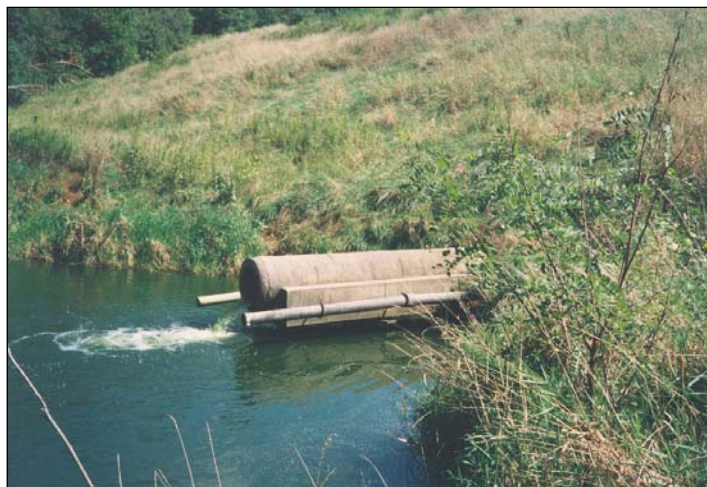
Figure 5-48 Collector pipes (beside spillway conduit) can be used to help monitor seepage through the embankment.

Many **toe drains** have collector pipes that discharge the embankment and foundation seepage at accessible locations. Before conducting a visual inspection of an embankment dam that has toe drains, the inspector should review the site plan to determine the location of the toe drains and outfalls. Previous data on both the reservoir level and flow rate from the drain(s) should be reviewed. Data on drain flow must be looked at in conjunction with reservoir-level data. Correlating the reservoir level with the drain flow can help to determine if there is a problem. If a drain flow is observed that is atypical for the given reservoir level, more investigation is essential.

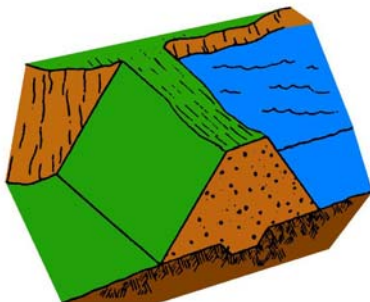
PROBLEMS**CREST ALIGNMENT**

1. Movement between adjacent portions of the structure.
2. Uneven deflection of dam under loading by reservoir.
3. Structural deformation or failure near area of misalignment.

1. Area of misalignment is usually accompanied by low area in crest which reduces free board.
2. Can produce local areas of low embankment strength which may lead to failure.

1. Establish monuments across crest to determine exact amount, location, and extent of misalignment.
2. Engineer should determine cause of misalignment and supervise all steps necessary to reduce threat to dam and correct condition.
3. Monitor crest monuments on a schedule basis following remedial action to detect possible future movement.

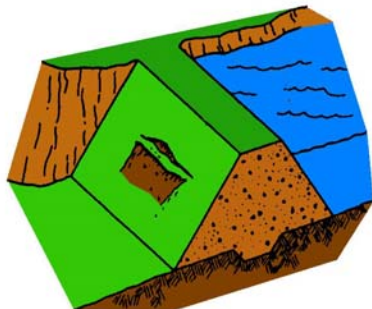
PROBLEMS**SLIDE/SLOUGH**

1. Lack of or loss of strength of embankment material.
2. Loss of strength can be attributed to infiltration of water into the embankment or loss of support by the foundation.

Can lead to failure of the dam.

1. Measure extent and displacement of slide.
2. If continued movement is seen, begin lowering water level until movement stops.
3. Have a qualified engineer inspect the condition and recommend further action.

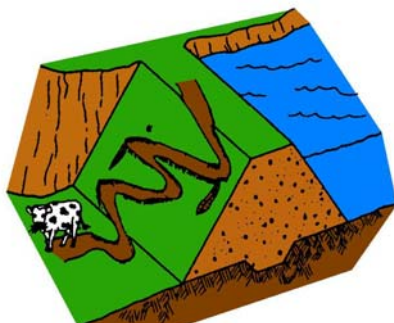
LIVESTOCK/CATTLE TRAFFIC

Excessive travel by livestock especially harmful to slope when wet.

Creates areas bare of erosion protection and causes erosion channels. Allows water to stand. Area susceptible to drying cracks.

1. Fence livestock outside embankment area.
2. Repair erosion protection, i.e., riprap, grass.
